Service Info

Frequent cause of failure in the timing drive

Excessive bearing play on the coolant pump

Engines: 1.4 16V, 1.6 16V

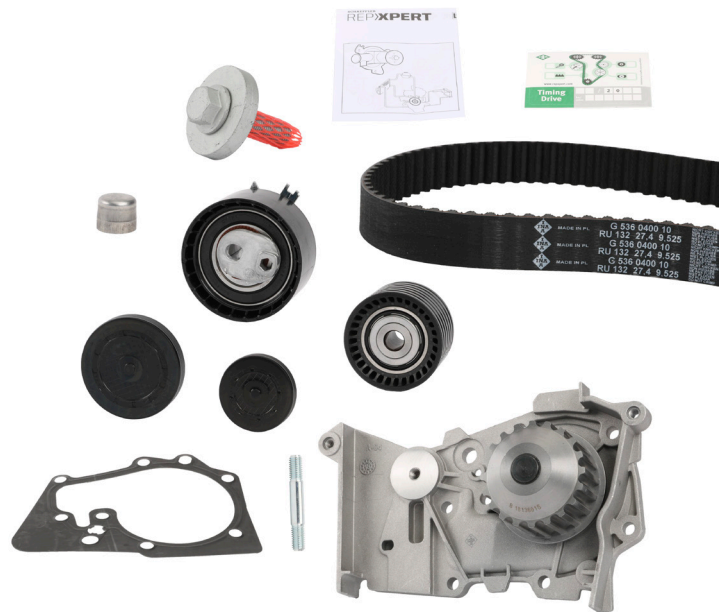
530 0640 30 – Coolant pump with timing belt kit

Excessive bearing play is appearing increasingly frequently on coolant pumps fitted ex works. As a result, the sides of the timing belt will run against the camshaft sprocket belt guides with excessive force damaging them, and also the belt. Fragments can come loose, and destroy other components in the timing drive.

To avoid additional costs arising at a later stage, the coolant pump should always be replaced when replacing components in the timing drive.
